Building Assessment Studies and Cost Estimates
for
Capital Improvements
at the
Jail (Public Safety Building)
and
Work Center

Whatcom County - Contract 201607005 – PHASE 1A

11 OCTOBER 2016

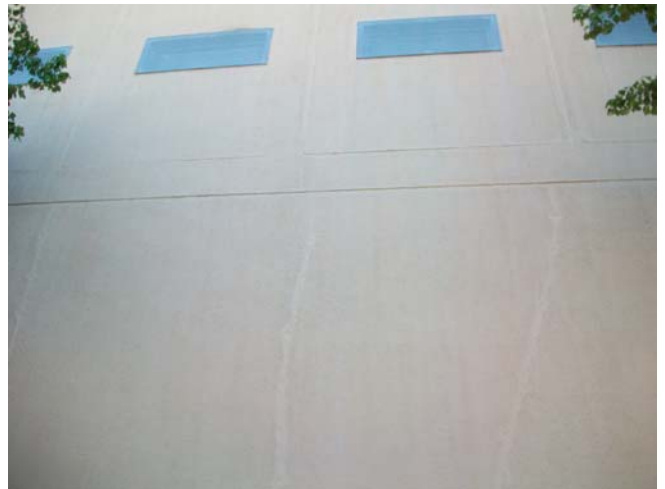
- I. The exterior finish of the building is gunite applied to cast-in-place concrete walls. There are some vertical cracks in the gunite, notably where control joints were left out. These have been filled with sealant and painted over some years ago. The gunite finish is dirty but otherwise in good condition.
- II. There are very few exterior openings. Most are in fair condition and doors are operable but could also use cleaning and new paint. No window leaks were mentioned. Exterior door hardware appear to be operable and in good condition.
- III. The Thermoplastic Polyolefin (TPO) roofing is approximately 15 years old. The insulation below may be delaminating, as the roofing "crackles" when it is walked on. It is not fully adhered to the substrate and is thus causing many areas of ponding. The paint on the parapet cap is peeling which will cause it

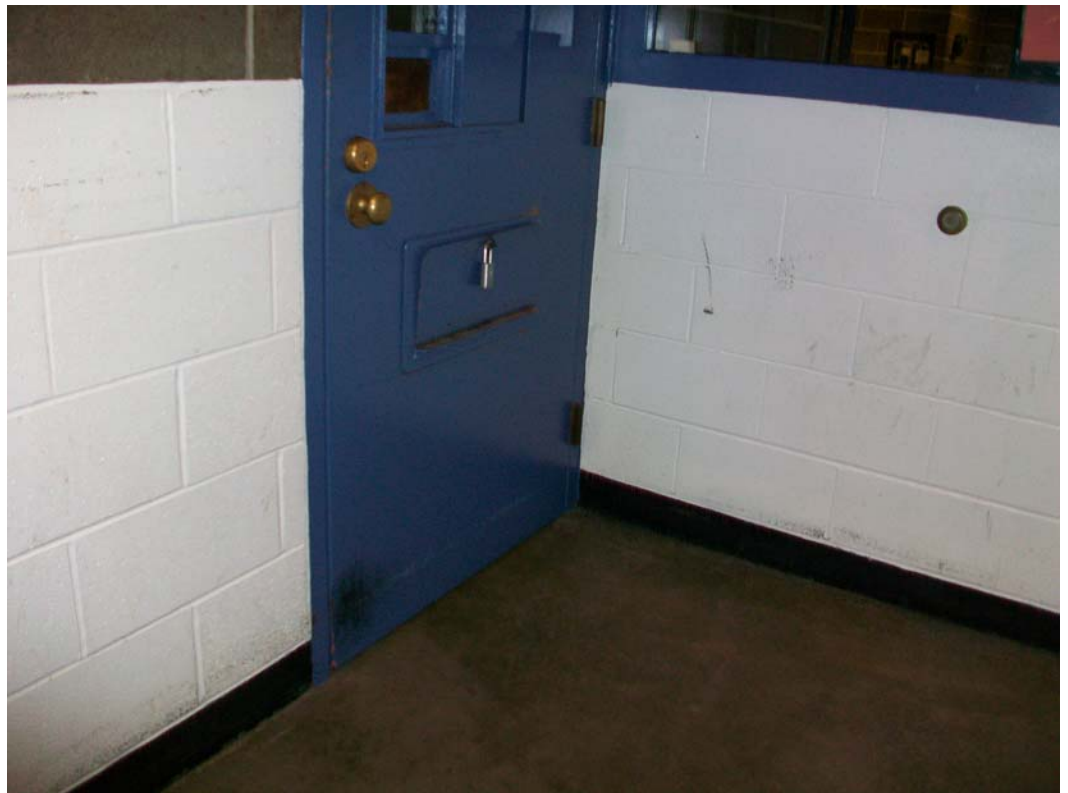
- to deteriorate more rapidly. The vents thru the roof are well flashed but are made of metal and have deteriorated from rust. There are no overflow drains adjacent to the roof drains.
- IV. Steps to the basement entrance of the Sheriff office included a metal tread and riser set over the concrete, which may not meet the slip resistance required for exterior stairs. Handrails do not meet current code. There is no ramp to comply with accessible entrance requirements.
 - V. Interior metal doors are all in poor condition. Paint has peeled off in many locations, promoting rust and dirt to increase the deterioration of the doors.

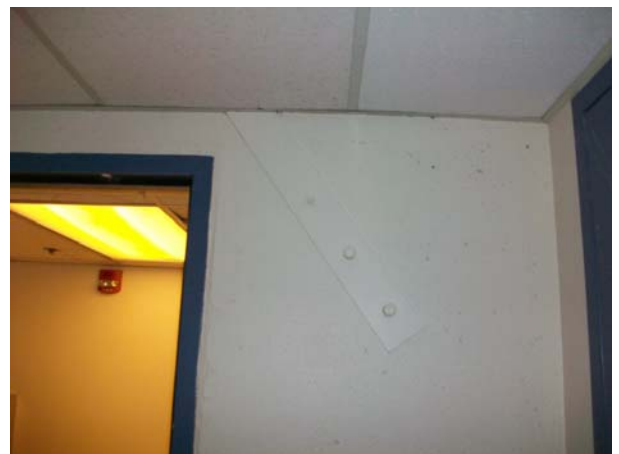
- II. Lateral System:
3" concrete topping over 8" to 16" thick hollow core slabs provide horizontal diaphragm action to distribute tributary forces to the vertical lateral resisting system in accordance with its stiffness, which will consist of exterior and interior reinforced concrete bearing/shear walls. Shear walls in turn distribute their loads to the grade beam/pile cap and pile system. In the Basement, openings were cut in the shear walls to provide continuous access from corridor to corridor. These were noted in the December 2000 report by DLR Group entitled "Whatcom County Jail Exiting Analysis Structural Repairs Report. The report provided details for reinforcing the cut openings and noted "As such, cutting the above described openings has not reduced the required capacity of the wall for the design lateral loading."

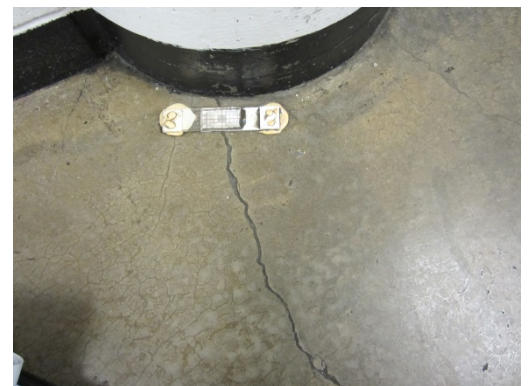
- Slab on grade appears in good condition.
- Floor slabs appear to be in good condition with shrinkage cracking which appears to be in the topping slab, not unexpected in a 3 inch topping over hollow core slab. Invasive testing or verification is not necessary or recommended.
- Roof slab was covered by membrane but did not appear to be showing signs of deflection or distress.
- Basement walls where observed appeared to be in good condition.
- Exterior concrete walls showed some shrinkage cracking, which is normal for concrete, particularly since control joints were not used; these cracks were injected with epoxy about 10 years ago and wall is in good condition.
- The in-fill concrete masonry unit walls that we observed were all in good condition. Concrete masonry units are usually sensitive to building movement, and will show signs of cracking with even minor settlement or

distortion. The concrete masonry unit walls we observed did not show signs of distress.

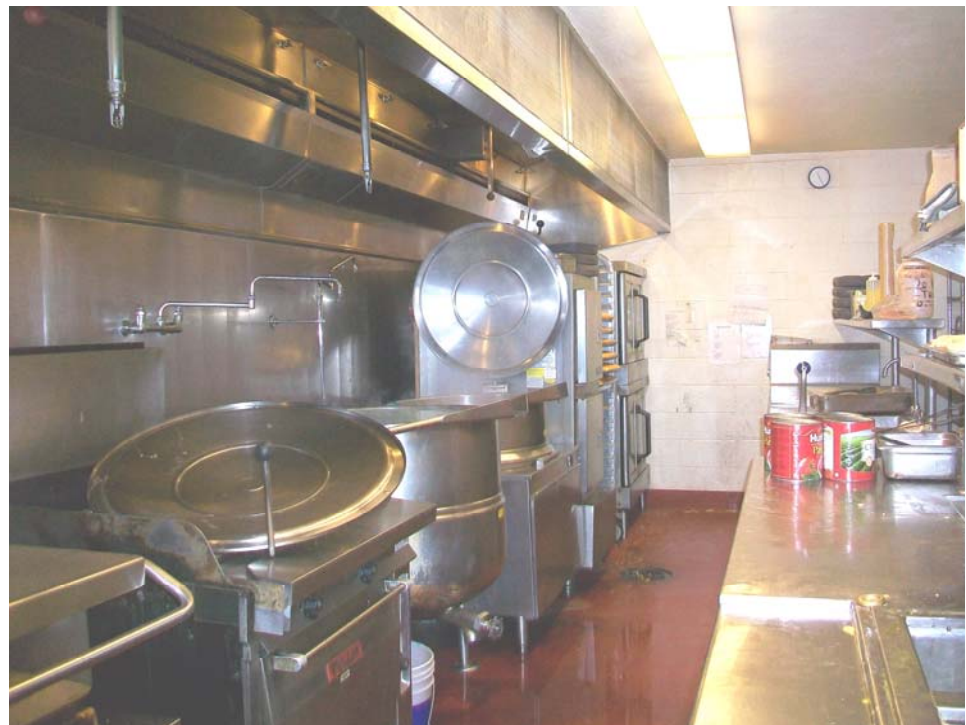
The kitchen was originally constructed in 1984 with much of the original equipment still in place. The kitchen is undersized for the populations being served and is especially short on space for dry and cold food storage. In fact, the main dry food storage room is remotely located on the 3rd. floor of the building making efficient use of this space difficult.

While some kitchen equipment items have been replaced over the years most of the main components remain from the original opening. Along with being short on space, and even though it was refurbished in 2014, the walk-in cooler and freezer assembly has more than exceeded a typical life span. The exhaust hood contains a fire suppression system that is no longer allowed based on current codes. The dishwasher has been replaced twice but is having repeated mechanical issues. There is also no system in place for drying of trays. Currently they are just banged against a table to get most of the water off and then stacked while still partially wet. The steamer and steam generator have been replaced but are due to be replaced again. Other individual cooking equipment items are in need of replacement as well.

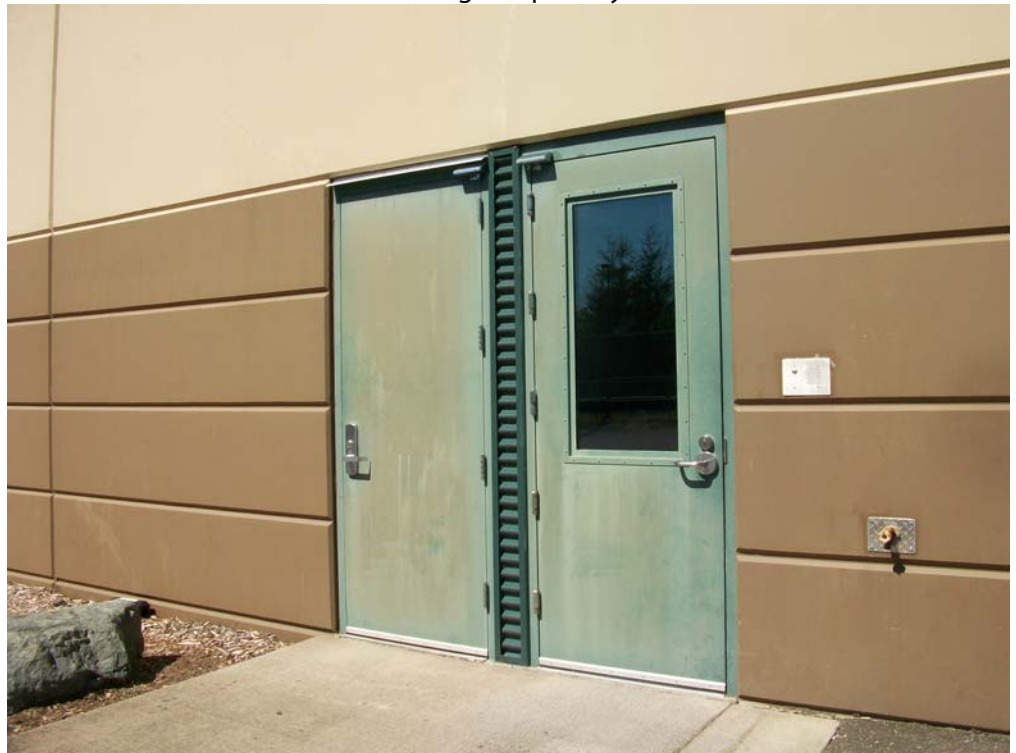
- I. Exterior Tilt-up concrete panels are in good condition.
- II. Paint on the south side of the building is especially faded.

- III. Paint on the exterior metal doors on the south side of the building is faded from the sun and is to the point where it could be detrimental to the material
- IV. Interior walls are in good condition except for a few small areas of damage from rolling a cart or something similar down the hall
- V. Interior layout in the office area does not meet current accessibility or exiting codes
- VI. Toilet and locker rooms are inadequate in size for the number of employees

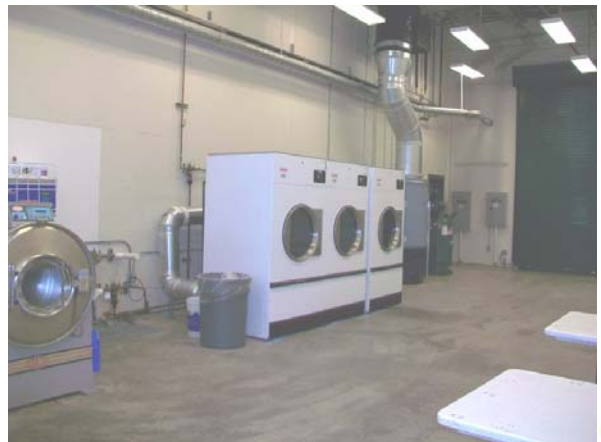
The laundry space and equipment is more than adequately sized for the number of items being done, allowing the operation to only be needed to be in operation during the evenings. The washer/extractors, dryers and lint collection system are the original items installed at the time of opening and are in good working order.
