Building Assessment Studies and Cost Estimates
for
Capital Improvements
at the
Jail (Public Safety Building)
and
Work Center

Whatcom County - Contract 201607005 – PHASE 1A

11 OCTOBER 2016

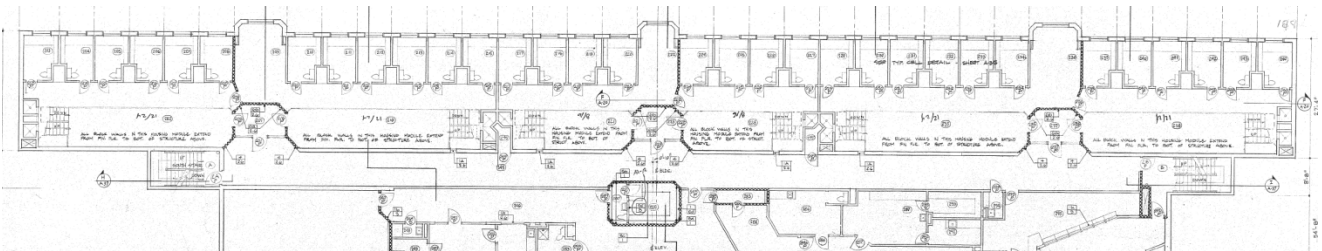
13. Because of the **housing unit's linear cell layout**, observation by staff into the housing units is very limited and in some cases non-existent. Blind spots exist. This is a potential violation of "The Prison Rape Elimination Act" (PREA). Cameras must be relied upon to observe inmates in the
