Response to Public Works Comment 5:

5. *Provide downstream analysis for the stormwater discharging to the Pleasant Bay Road ditch and beyond to Pleasant Bay.*

1. Figure 1: *Governors Point, Downstream Ditch*
2. Figure 2: *Governors Point, Typical Ditch Cross Sections*

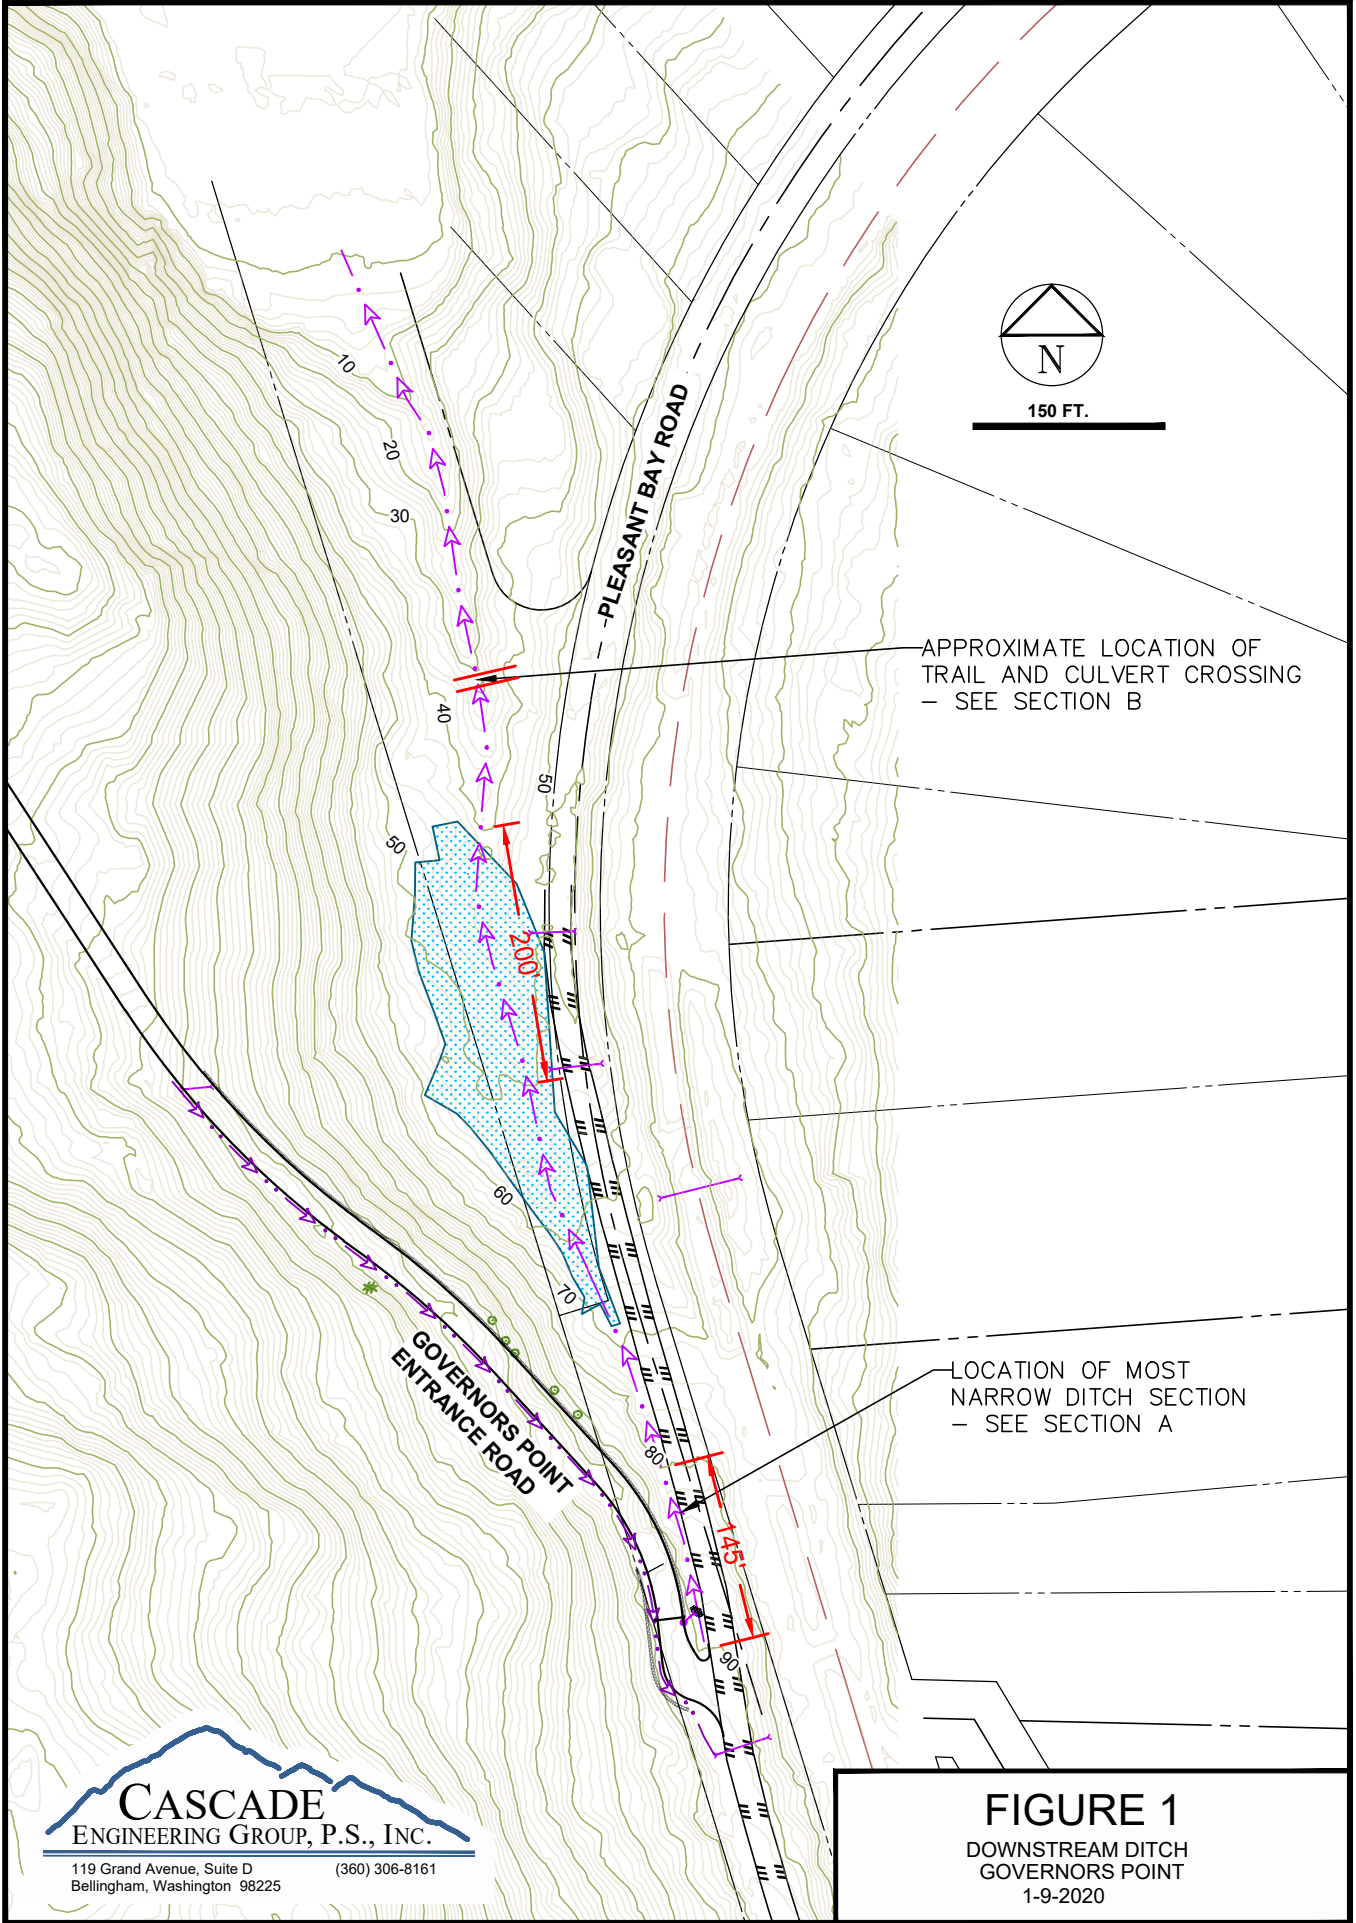
FIGURE 1
 DOWNSTREAM DITCH
 GOVERNORS POINT
 1-9-2020

Figure 3: *Cross Culvert Basins*, provided in our October 23, 2019 response to the August 14, 2019 NOAR, shows the locations of the stormwater discharge points and roadside ditches along Pleasant Bay Road. Figure 1, *Downstream Ditch*, of this (January 9, 2020) response shows a more detailed plan view of the Pleasant Bay Road ditch.

Two areas were identified as representative for evaluating the ditch. The first location, identified as Section A in Figure 1, shows the narrowest section of the ditch. At this location the ditch is "V" shaped, approximately three feet wide, one foot deep, and has an approximate slope of 7%. The second location is at the ditch's trail crossing. The ditch has a four foot wide flat bottom, is approximately 3.5 feet deep to the top of the trail, and has an approximate slope of 5%. Figure 2, *Typical Ditch Cross Sections*, provides details of these two ditch sections.

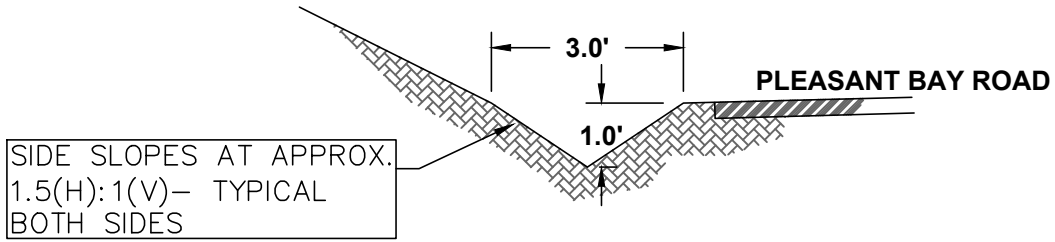
SECTION A - LOOKING NORTH
TYPICAL DITCH CROSS SECTION AT NARROWEST POINT
(DIMENSIONS ARE APPROXIMATE)

SIDE SLOPES AT APPROX.
1.5(H):1(V) – TYPICAL
BOTH SIDES

Section A – Narrowest Ditch Section

A visual inspection was performed and the ditch was observed covered with low profile vegetated ground cover. This vegetation did not appear to impact the flow of runoff in the ditch and no signs of erosion or exposed soils were observed. Assuming the one-foot deep ditch has six-inches of base flow, the estimated ditch flow rate is 1.47 cfs. With the additional 0.20 cfs flow (for a new total flow rate of 1.67 cfs), the estimated flow depth is 0.52 inches, or an increase in flow depth of about ¼-inch. This increase in flow is not a significant impact on the ditch and well within the existing ditch's capacity.

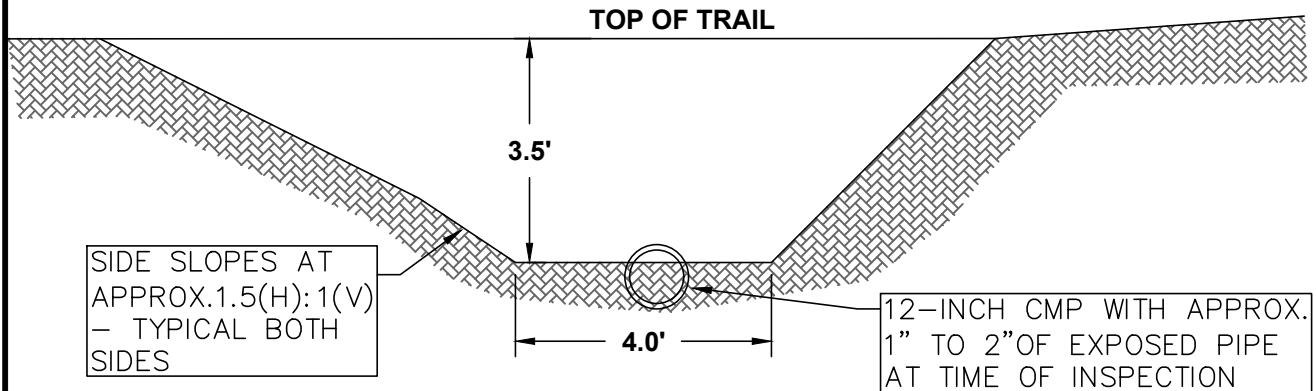
SIDE SLOPES AT
APPROX. 1.5(H):1(V)
– TYPICAL BOTH
SIDES

12-INCH CMP WITH APPROX.
1" TO 2" OF EXPOSED PIPE
AT TIME OF INSPECTION

Section B – Ditch Section at Trail Crossing

As the ditch extends north of the project entrance road, it moves west away from Pleasant Bay Road and becomes wider, both at its base and at its top, as it drops lower the adjacent terrain. A significant amount of water is added to the ditch from two crossing culverts conveying runoff from the east side of Pleasant Bay Road into this ditch. A visual inspection was performed and the ditch has areas of an exposed aggregate base, especially in the center of the channel. Evidence of soil transport was observed in the 12-inch diameter corrugated metal pipe below the trail. Only the top two to three inches were clear of sediment and flow was conveyed through this area downstream. No signs of distress (excessive erosion or loss of vegetation) were observed in the ditch at this crossing, both upstream and downstream of the culvert. The ditch either was able to self-scour the pipe clean under high flow conditions and/or the culvert is maintained by the property owner, Chuckanut Beaches, Inc.
